AVIATION INVESTIGATION REPORT

A04O0237

FLIGHT CONTROL DIFFICULTIES

DE HAVILLAND DHC-8-102 C-FGRP

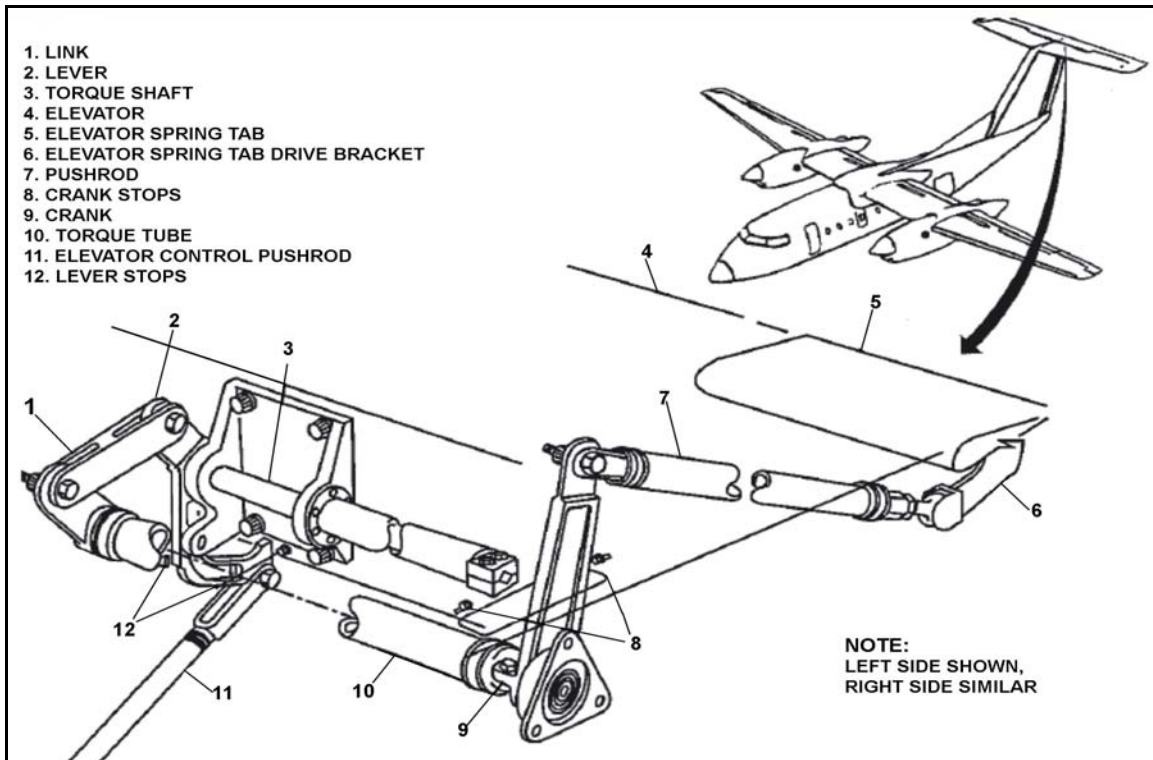
Figure 2. Elevator control

When the elevators are actuated, the control column movements go directly to the spring tab and then to the elevator through the torque shaft (see Figure 2, item 3). With the airplane on the ground and no aerodynamic load, the stiffness of the torque shaft overcomes the weight of the elevator, causing it to move with the control column. The geometry of the actuating hardware causes the elevator to move in the opposite direction to the spring tab. Maximum spring tab deflection is limited by the crank stops (Figure 2, item 8), after which the elevators are moved directly by the control column. Maximum elevator deflection is limited by the lever stops (Figure 2, item 12).

The flight data recorder showed that the two elevators were moving approximately in sync with each other until the aircraft was accelerating on the take-off run. The maximum differential in elevator deflection was reached when the airspeed was at approximately 120 KIAS; the right elevator was approximately 12° trailing edge up and the left elevator was approximately 8° trailing edge down. According to calculations completed after the occurrence, at 185 KIAS, the stress on the tail was close to its structural limit, and a specific, one-time maintenance inspection was designed to look for additional damage.

When the right elevator spring tab was checked, it was nose heavy and required rebalancing. This work was not noted on the check sheets. Checking the balance of the elevator spring tab is accomplished by disconnecting the tab drive bracket (Figure 2, item 6) from the pushrod (Figure 2, item 7) and attaching a specific weight to the trailing edge of the tab. The rebalancing was accomplished by removing the steel balance weights and grinding some material from the
